Backplane and Midplane Vision Inspection System

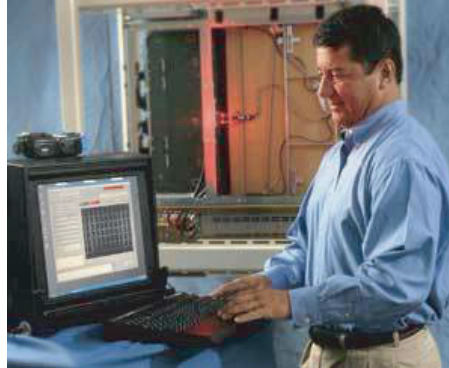
New Method

Using miniature optics and drive components mounted within a card that is mechanically compatible with a system card, the Scorpion Pin Inspection System can scan the backplane or midplane of a system rack, using only the width of a single slot. Scorpion eliminates the need to remove cards or partial disassemble the rack to perform an inspection.

The user configurable Scorpion software drives the scanning process while also performing the evaluation and data logging. The software will obtain the coordinates of bent or missing pins, capture the image, and display the findings in a result panel. Following the inspection, the operator can use the results data to quickly go to the stored or live image of the failed pins.
