Solar Panel Inspection System

To develop an inspection station to capture and process image data for solar panels in production.

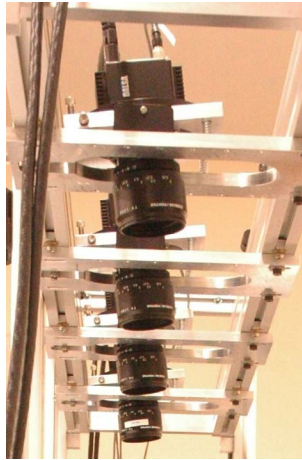
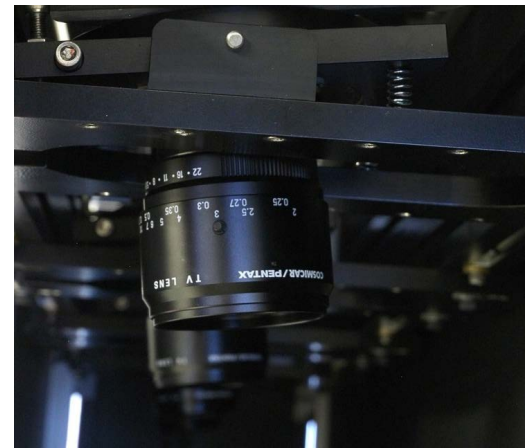
PVI Systems designed a fully automated final assembly inspection station for solar panel production lines. The system features top and bottom imaging with a total of eight linescan cameras. System calibration is comprised of many functions, including spacial (X & Y), Intensity (Gain and Black Level), Focus, and Alignment (Angular and Translation). The inspection station has the ability to accept parts from a conveyor system, capture images of both front and back sides, and process images to determine a pass/fail status.

Image processing for these features were developed in LabVIEW with NI Vision from National Instruments (NI). Linescan cameras are used with line lights to image the entire front and back surfaces of parts.

- Dalsa Spyder 4096 pixel linescan cameras
- Database collection via OPC
- Image acquisition via NI PCIe-1430
- Advanced Illumination 72 inch white LED line lights
- Acquires 229 megapixels per part
- Allen-Bradley ControlLogix PLC with 24 PNP inputs and 24 outputs
- Allen-Bradley Kinetics 300 Ethernet Servo Drive
- Capable of processing a panel every 15 seconds
- Eight simultaneously acquiring linescan cameras

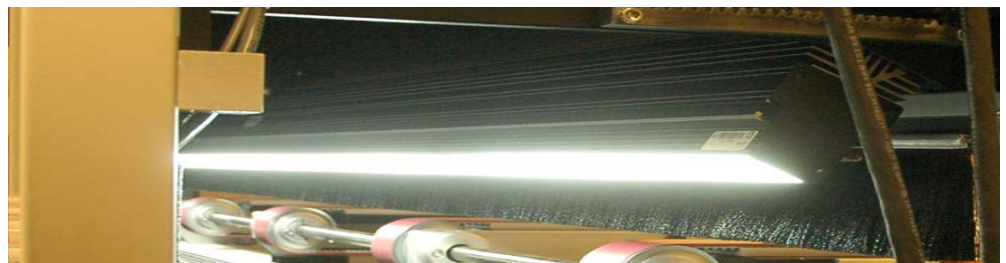
Deployment

The system is currently deployed on the Pacific Coast of the United States. It has the ability to determine a pass or fail status for each part and transmit data regarding the pass/fail status to the following tasks in the assembly.
